# Manhole Inspection Summary

Manhole # S27G\_\_012MH

Insp Date: **6/21/08 8:53 AM**

**Location** Address: **919 N Fairmount Av**

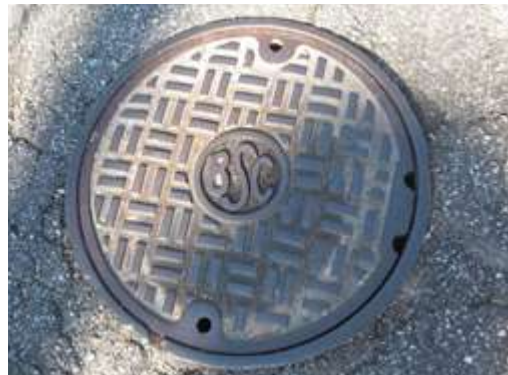
Cover View

Condition: **Broken**

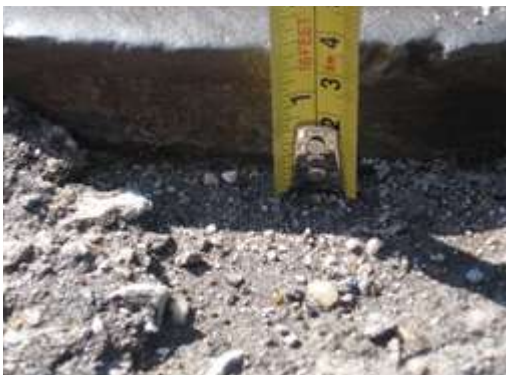
Manhole is above grade

a/d 1.25

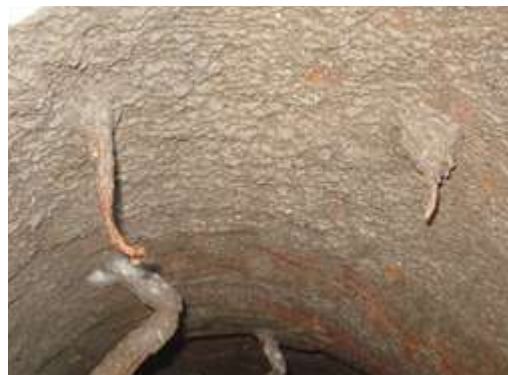
Defect 2

steps missing, corbel flow wall

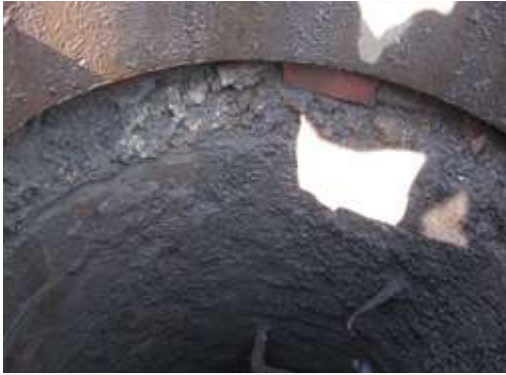
Defect 1

infiltration frame-chimney connect

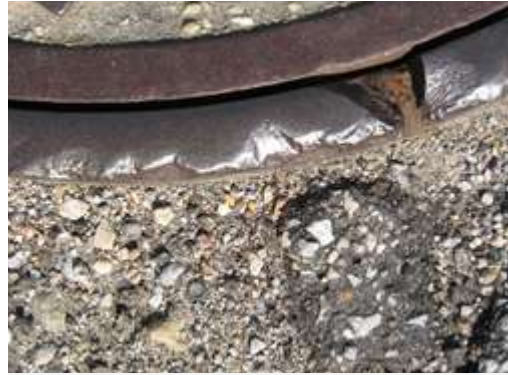
Defect 5

chipped frame, source of infiltration

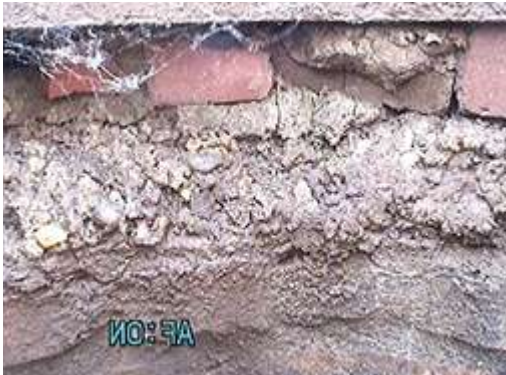
Defect 4

Condition: ☐ Sound ☒ **Cracked** ☒ **Leaks**

Condition: ☐ Sound ☐ Cracked ☐ Root Intrusion ☒ **Loose Brick** ☒ **Deteriorated**

Infiltration: ☐ None ☐ Joint ☐ Cracks ☒ **Mortar** ☐ Roots ☒ **Wall**

frame cracked, frame leaks, chimney  
cond loose bricks, chimney cond  
deteriorated, chimney mortar, chimney flow

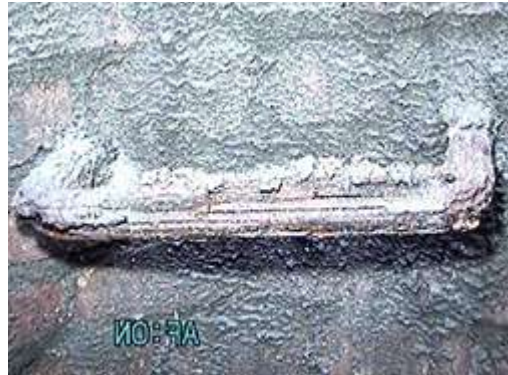
Defect 3

Count: **6** Missing: **1** ☒ **Corroded**

corroded steps

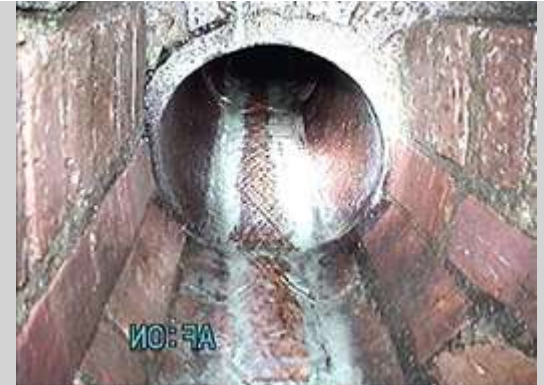
12 O'Clock Outflow

Pipe Height: **8.4** (in.) Rod and Bar (Angled)  
Pipe Material: **Clay** ☐ Pipe Lined  
Invert Depth: **10.23** (ft.) Flow Characteristics: **Fast**  
Deposits: ☒ None ☐ Mud ☐ Sludge ☐ Debris ☐ Grease  
Silt Depth: **0** (in.) Deposits Extent:  
Infiltration: **Evidence** Pipe Seal Cond: **Unknown**

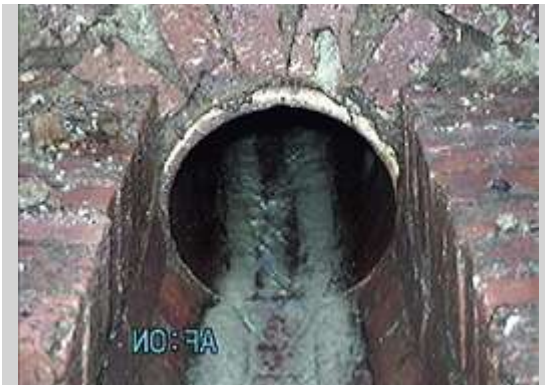
6 O'Clock Inflow

Pipe Height: **8.4** (in.) Rod and Bar (Angled)  
Pipe Material: **Clay** ☐ Pipe Lined  
Invert Depth: **10.20** (ft.) Flow Characteristics: **None**  
Deposits: ☒ None ☐ Mud ☐ Sludge ☐ Debris ☐ Grease  
Silt Depth: **0** (in.) Deposits Extent:  
Infiltration: **Evidence** Pipe Seal Cond: **Unknown**

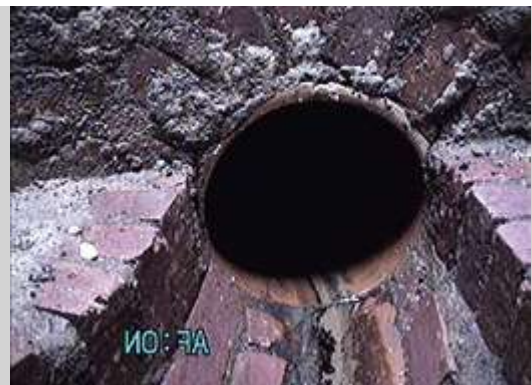
9 O'Clock Inflow

Infiltration: **Evidence** Pipe Seal Cond: **Unknown**
